DELAWARE RIVER BASIN
TROUT BROOK, SUSSEX COUNTY
NEW JERSEY

N. J. NO NAME

DAM NO. 36

PHASE 1 INSPECTION REPORT
NATIONAL DAM SAFETY PROGRAM

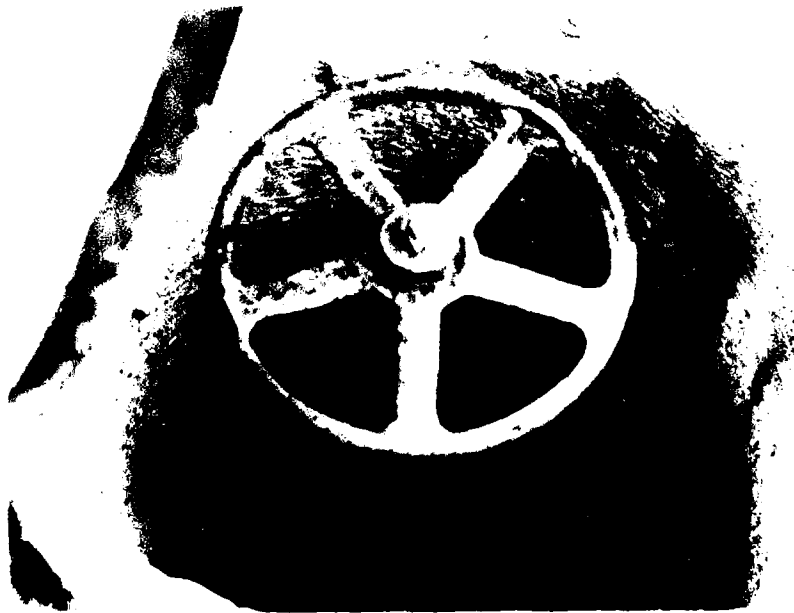
PHOTO 4
GATE OPERATING MECHANISM

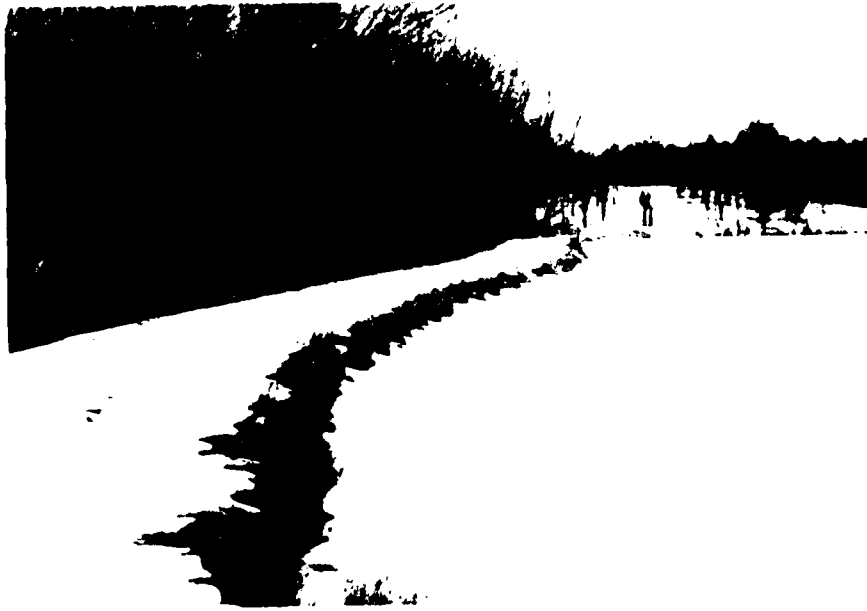
The crest of the dam appeared to be generally evenly graded although evidence of vehicle wheel ruts were observed. The crest and upstream face of the dam were grass covered with a few small trees located on the upstream face. There appeared to be some riprap located on the upstream face of the dam, but detailed observation was not possible due to the presence of ice and snow.

PHOTO 5
UPSTREAM FACE AND CREST OF EMBANKMENT

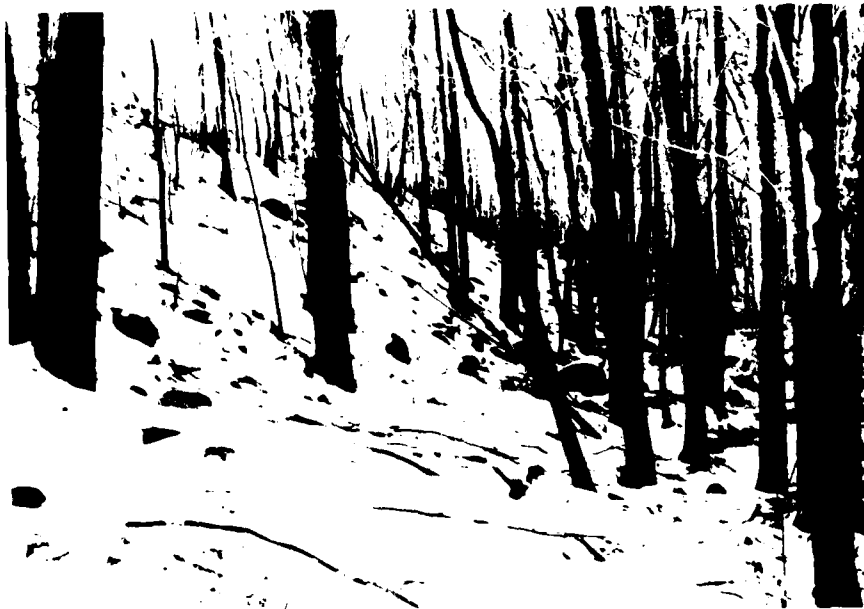
appeared to have a slope of 1 horizontal to 1 vertical. At at least two locations, the face was bulged out in relation to adjoining areas of the embankment. One bulge measured approximately 15 feet across and about 10 to 12 feet high. It protruded from the line of the downstream side of the embankment by approximately 2 to 3 feet. At the toe of the bulge, a spot which was wet and contained orange deposits indicating possible seepage was observed. Trout Brook which flows along a portion of the downstream side of the dam, was observed to lie very close to the dam at the point of the bulge.

PHOTO 6
DOWNSTREAM FACE OF EMBANKMENT

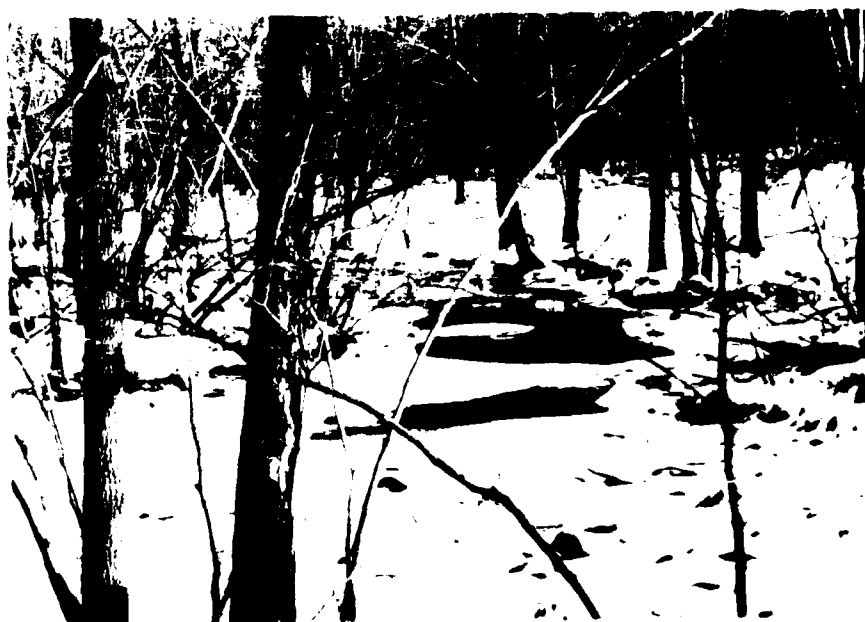
PHOTO 8
DOWNSTREAM CHANNEL
